The Fire Resistance Performance Of A Fire Blanket When Tested Utilising The Heating And Pressure Conditions Given In BS 476: Part 20:1987

541780/LR

**Prosol UK Sales and
Distribution Ltd**

Indicative Fire Resistance Test Letter Report

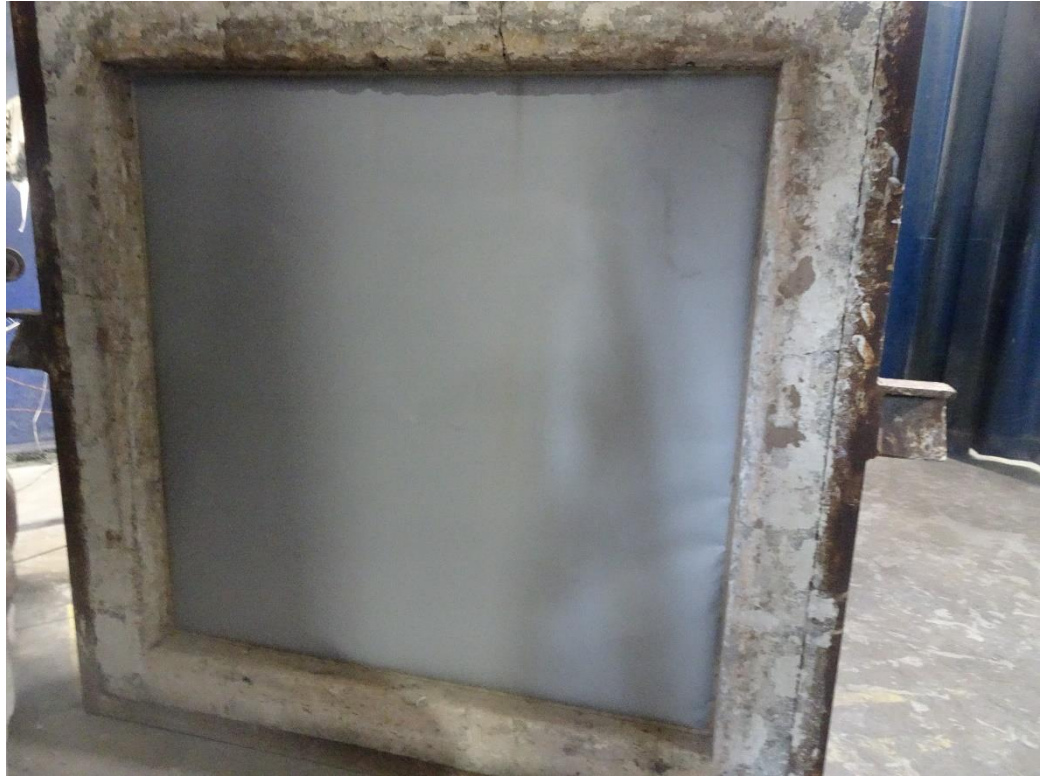
The exposed face of the test assembly prior to testing

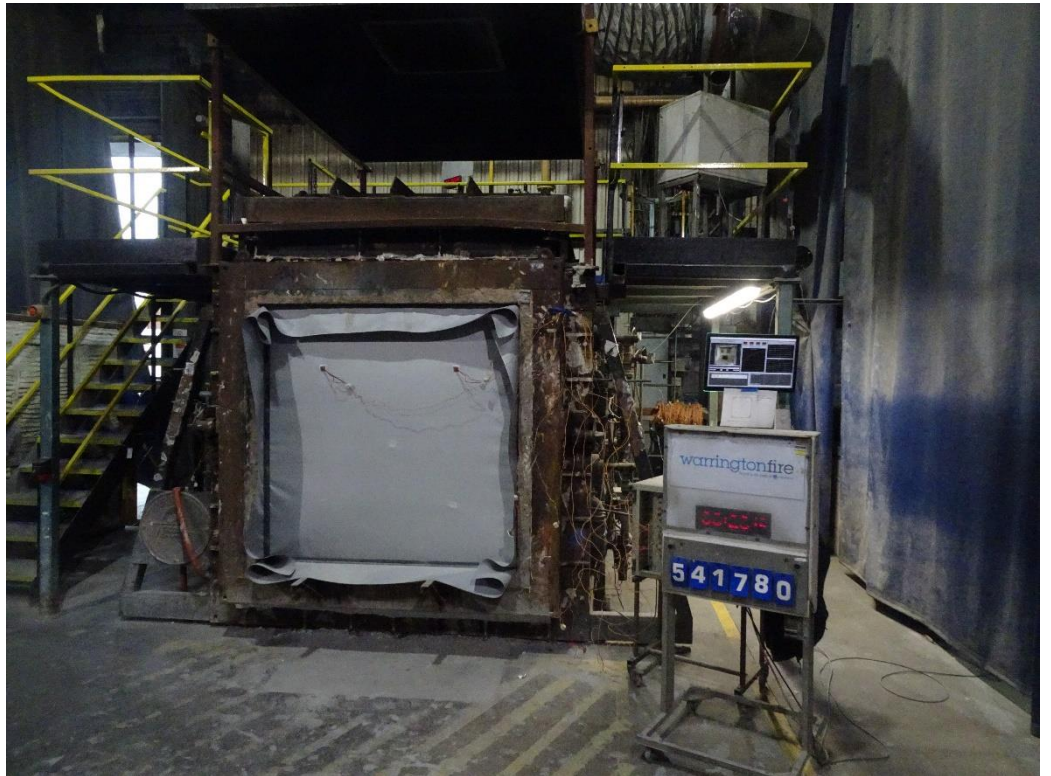
The unexposed face of the test assembly after a test duration of 20 minutes

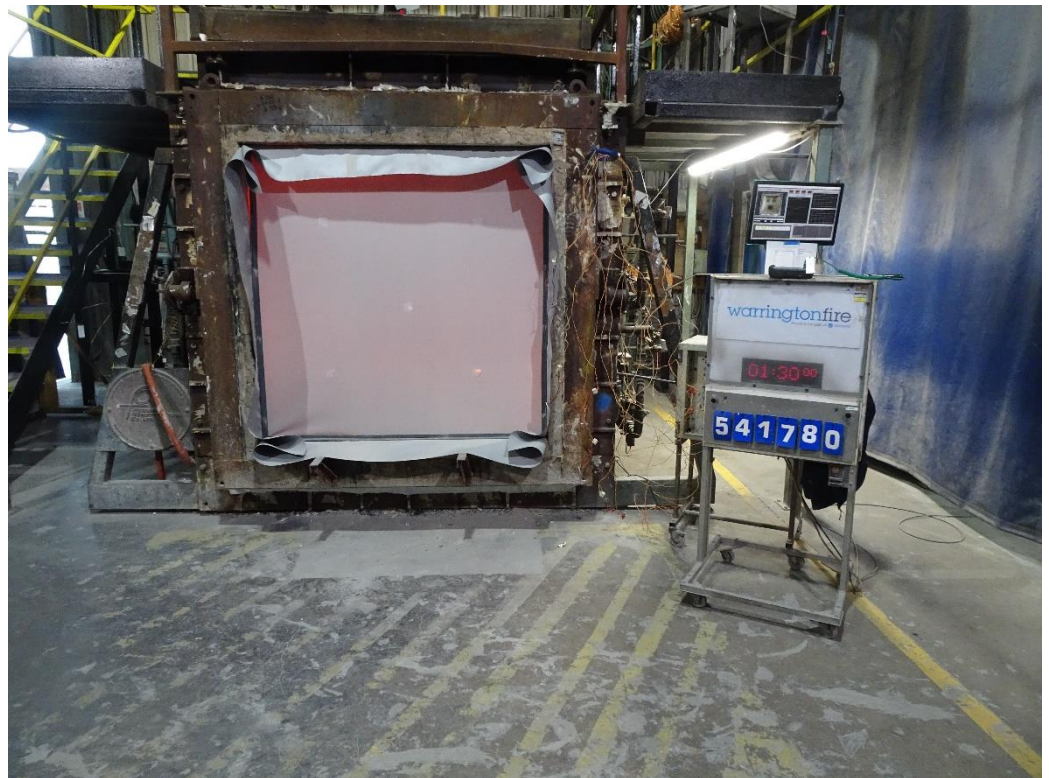
The unexposed face of the test assembly after a test duration of 90 minutes
